2726 W Cortez HOA  
2726 W Cortez  
Chicago, IL

RE: Inspection of on going masonry work at above address on 11-4-19

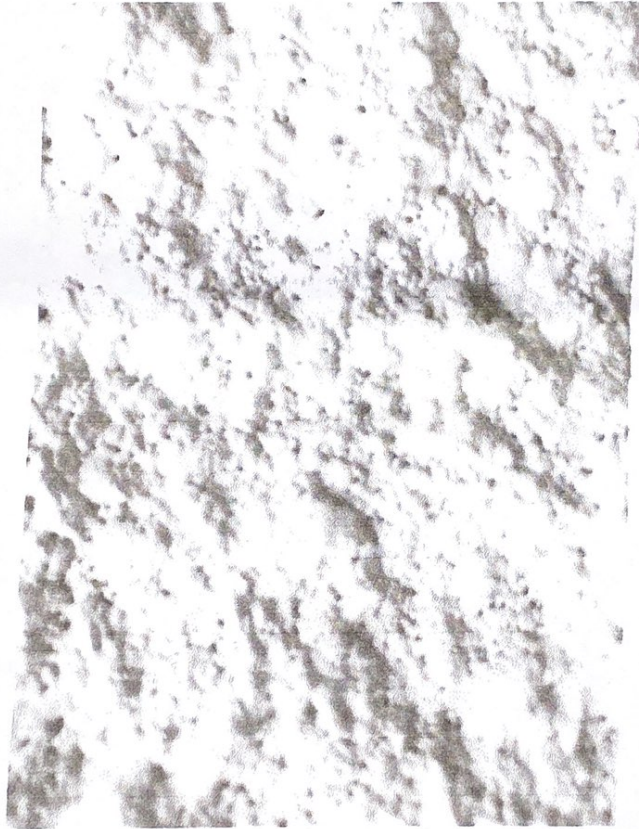
2726 w Cortez 11-4-19

A picture of a CMU Concrete Masonry Unit which is part of the east wall is enclosed. The pictures shows multiple pin holes in the PITFLEX coating. This is not up to the standards set by the manufacturer PPG.

This picture is consistent with other exterior wall areas.

Picture taken on east side 6 foot height. Picture similar to all painted block.

PPG should have a rep to verify installation of there product using company standards. It is my understanding that 2 coats should be installed and final product verified by PPG for a warranty.

Did the installer follow PPG guidelines ?
